U.S. Fish and Wildlife Service

Humboldt Bay National Wildlife Refuge
Humboldt County, California

Lanphere Dunes Restoration Photodocumentation

June 2017

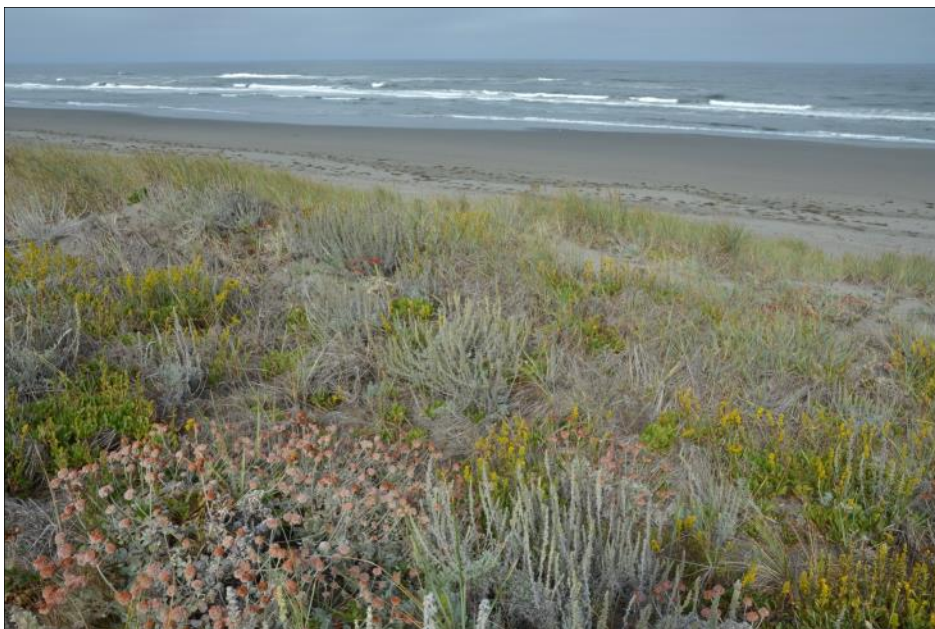
Photos this page: Restored foredune at the Lanphere Dunes Unit.; with seaside daisy (above) and American dunegrass, beach buckwheat, and beach sagewort (below).

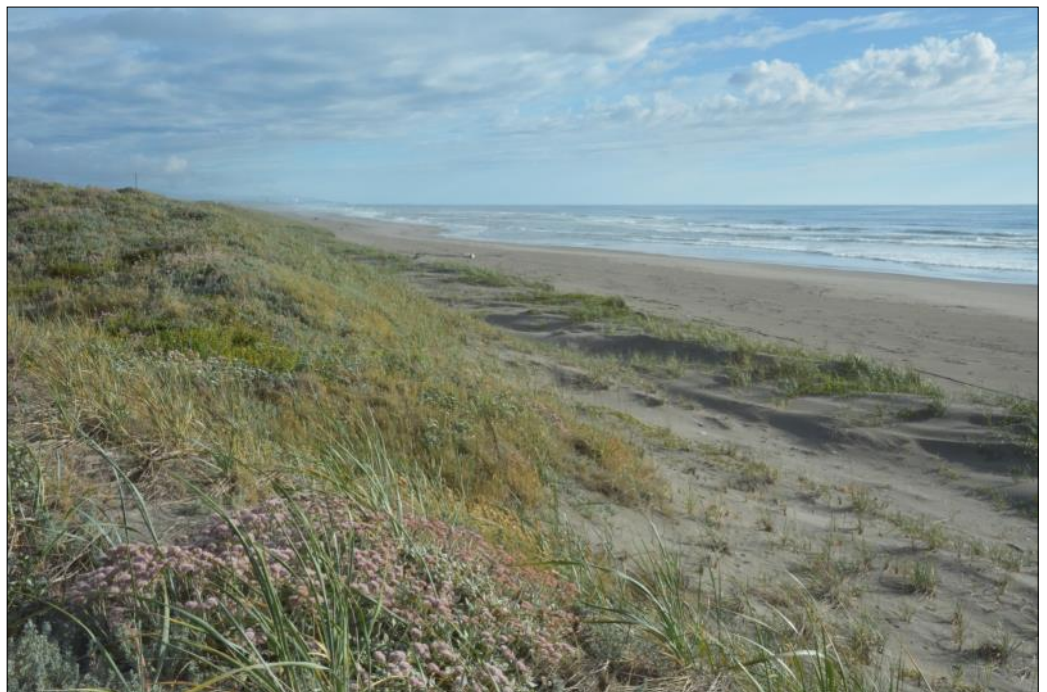
Restored foredune at the Lanphere Dunes Unit, with beach buckwheat in the foreground and American dunegrass on both the established and incipient foredunes.

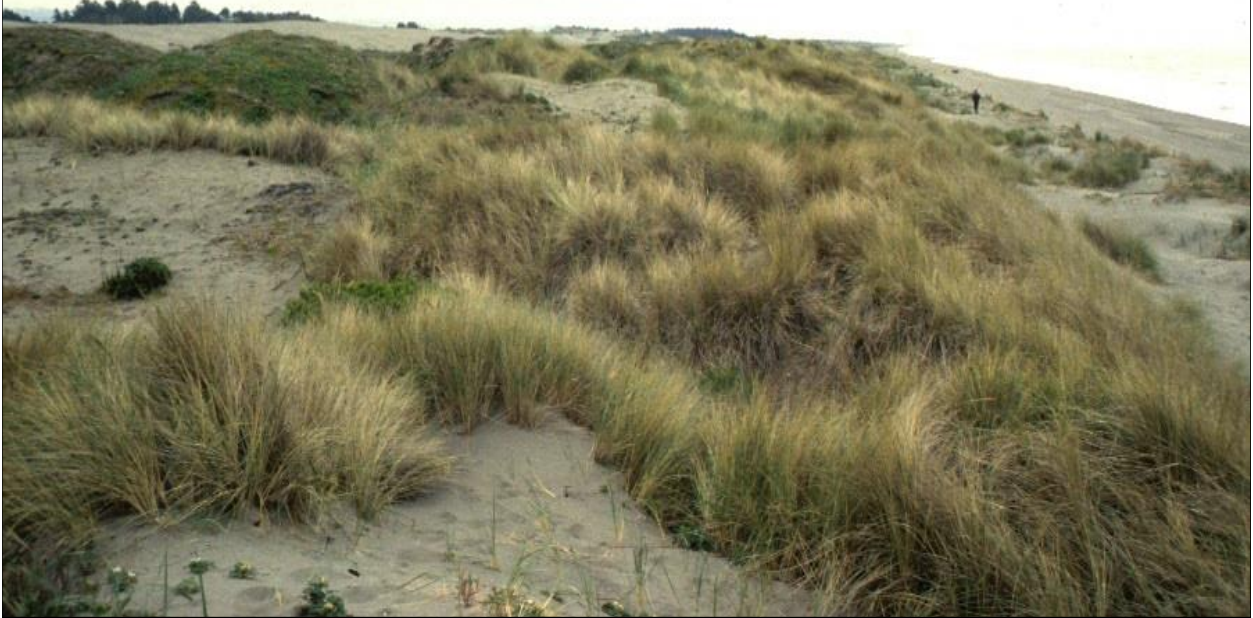
1995

Openings in the European beachgrass on the established foredune represent Phase 1 or 2 restored patches. The less densely vegetated incipient foredune visible to the right had not yet been treated.

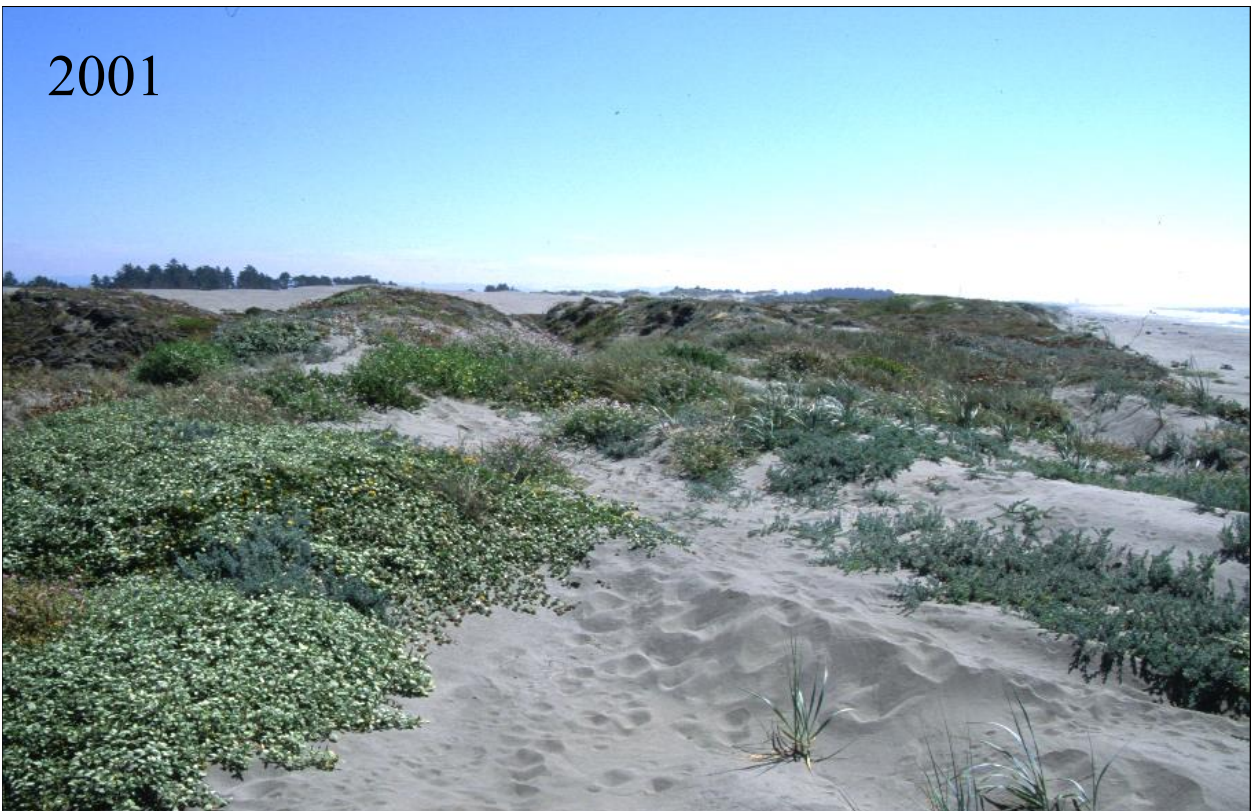
2001

Native vegetation is returning, especially the colonizing species beach bursage and beach pea, with a few plants of American dunegrass in the foredune. The incipient foredune has eroded.

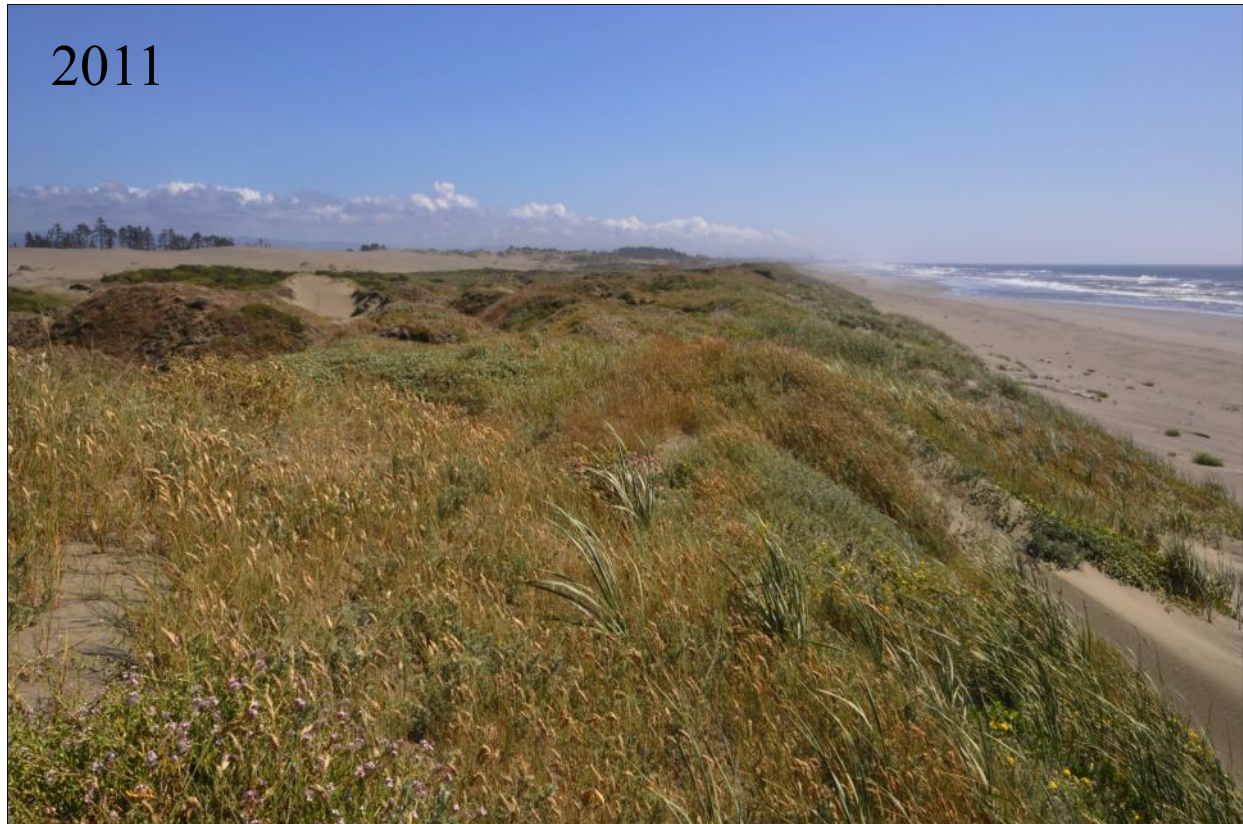
Photopoint 1 continued

Vegetation cover is more continuous, and beach bluegrass is more common. The incipient foredune is still lacking, and sand is accumulating on the seaward face of the established foredune.

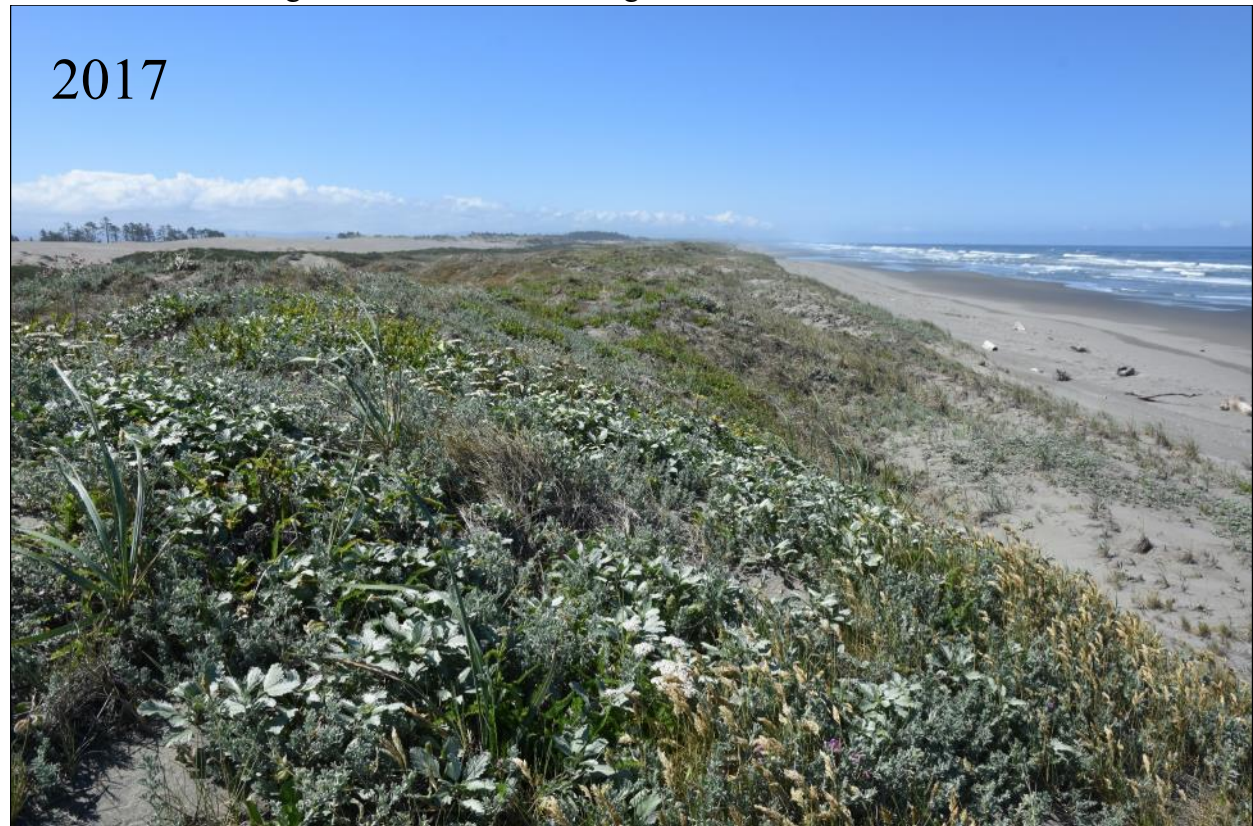
A broad incipient foredune has formed and is dominated by American dunegrass. Species on the established foredune include beach bluegrass, beachbur, American dunegrass, dune goldenrod, yellow sand-verbena, and yarrow.

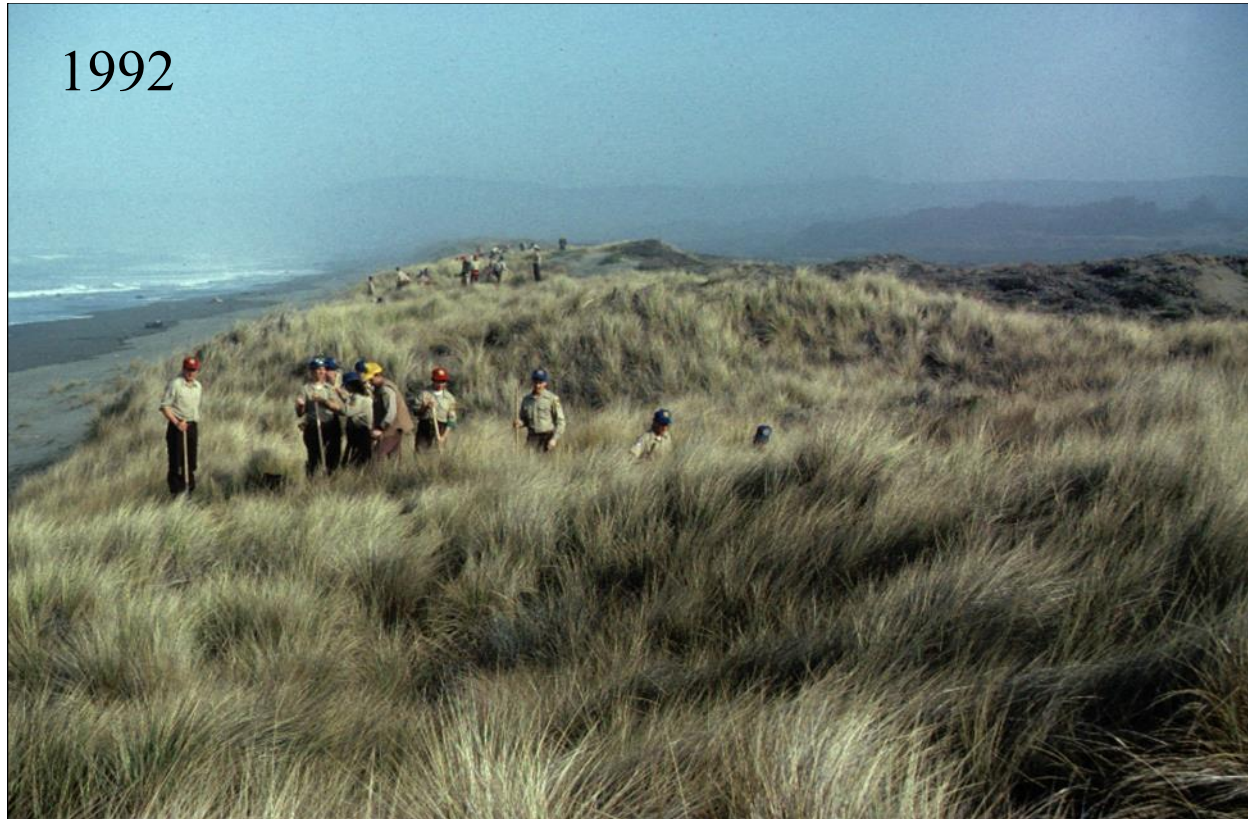
Photopoint 2

The California Conservation Corps begins removal of dense European beachgrass on the established foredune. There is no incipient foredune present in this area.

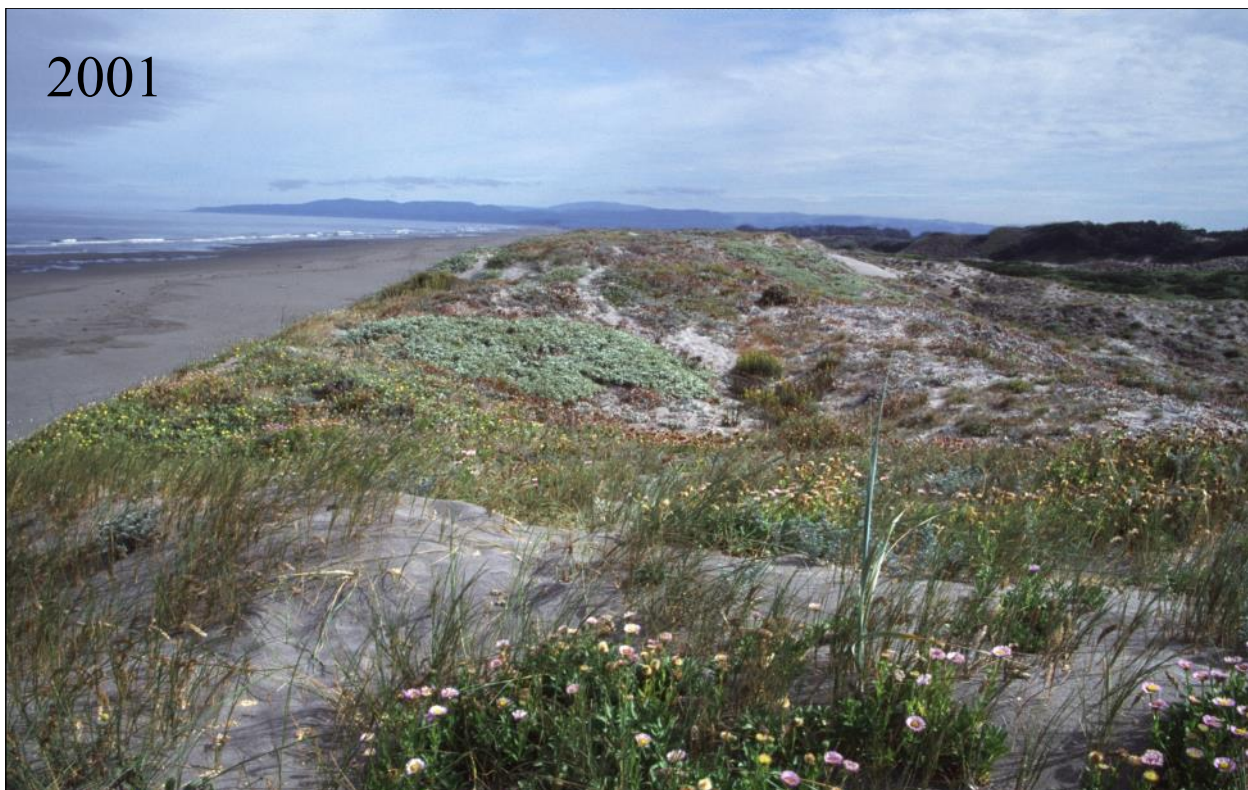
Vegetation is much more open and diverse, and is dominated by early successional species yellow sand-verbena, beach bursage, and lesser beach bluegrass and dune buckwheat. Sand is accumulating at the crest of the foredune in the foreground.

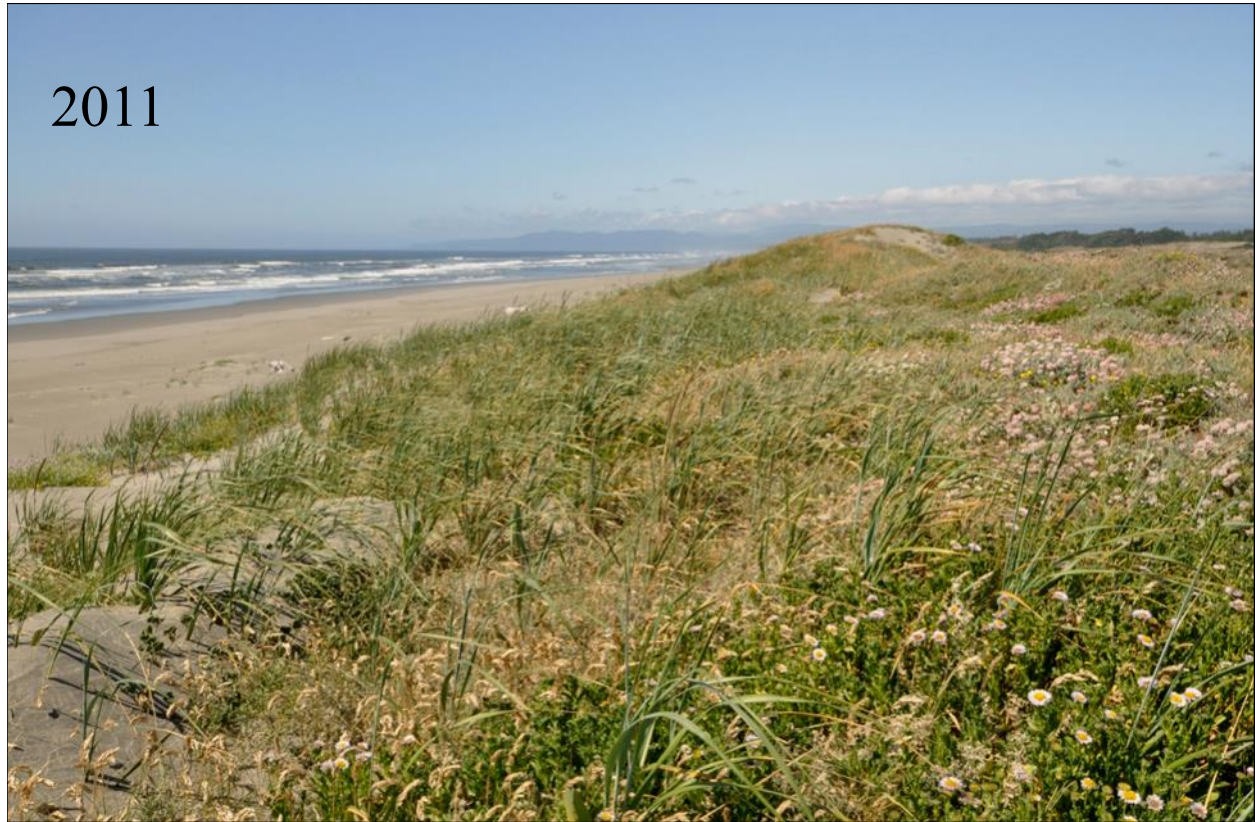
Photopoint 2 continued

An incipient foredune built by American dunegrass has formed west of the established foredune. Cover has increased on the established foredune, and beach bursage has been replaced by beach buckwheat.

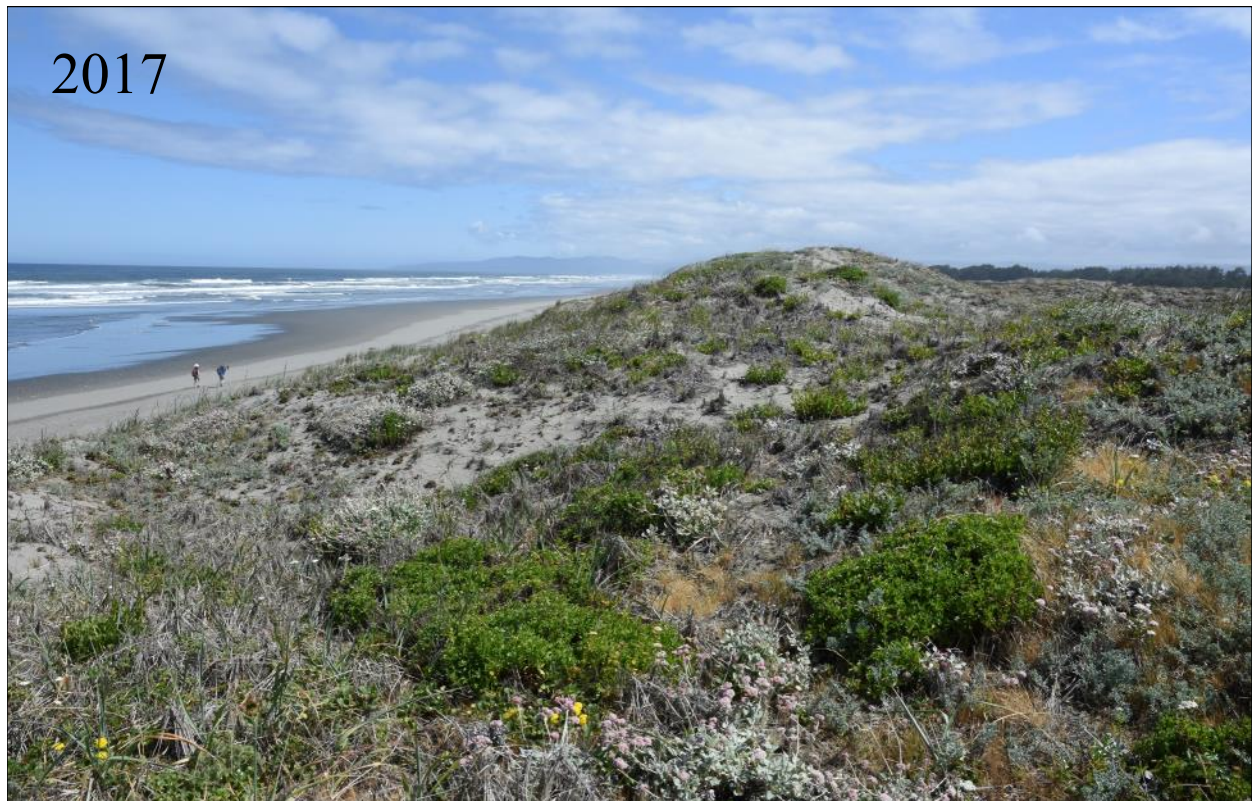
The incipient foredune is narrower following winter erosion. American dunegrass is now restricted to the incipient foredune where there is active sand deposition. Overall cover has decreased, possibly due to the drought during 2014-15.

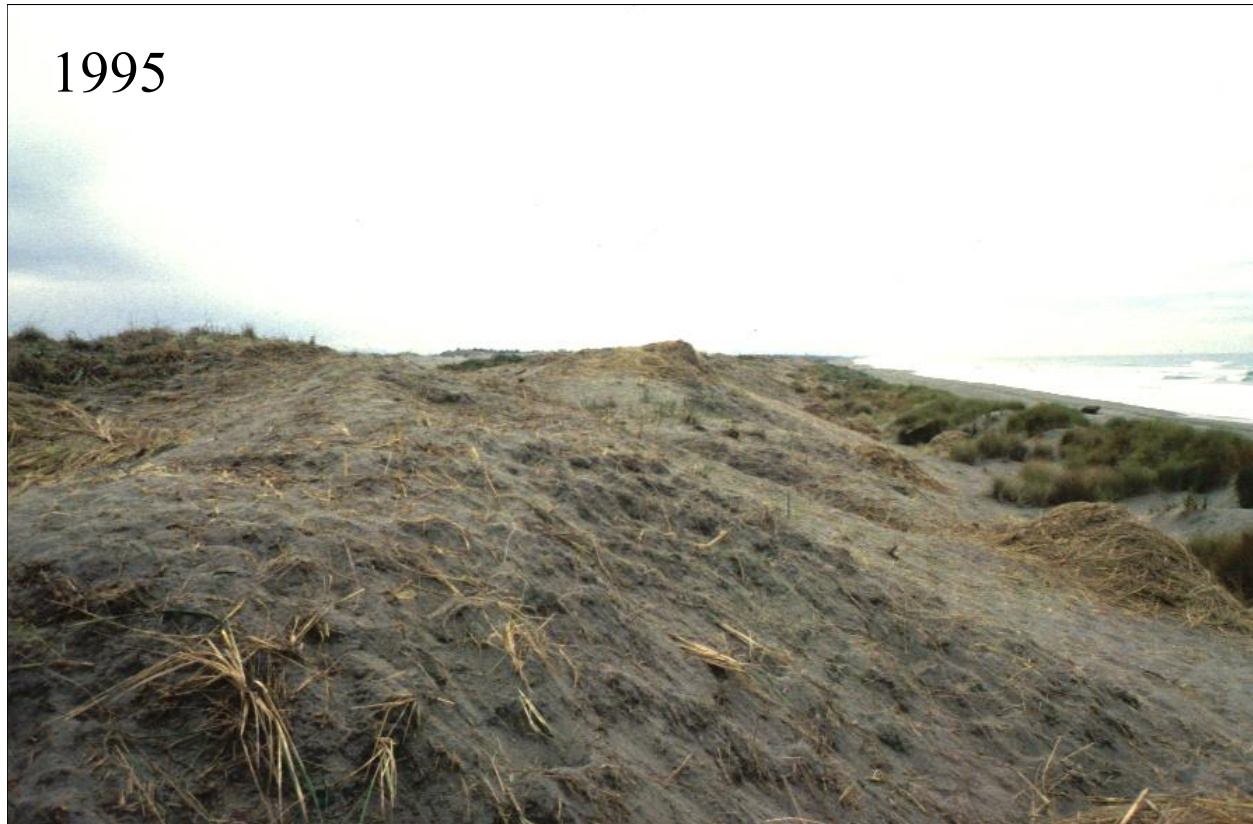
Photopoint 3a

This photo was taken just after beachgrass removal in Phase 3, although the incipient foredune to the right was not treated until the next year. The vantage point is from the base of a blowout to the north, visible on air photographs from this period.

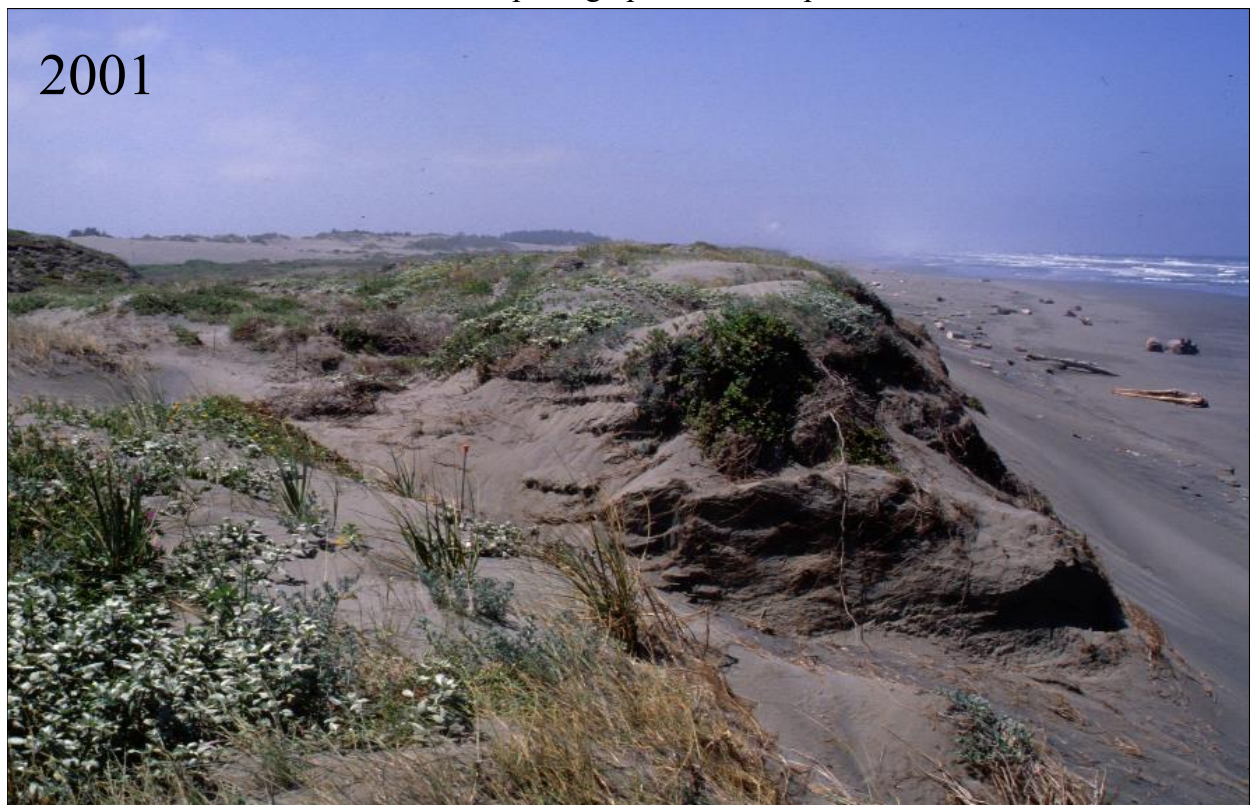
The blowout has enlarged and the new photograph is now taken the north rim of the blowout (farther north and east) in order to have a vantage point from above. The incipient foredune has eroded, reactivating the blowout.

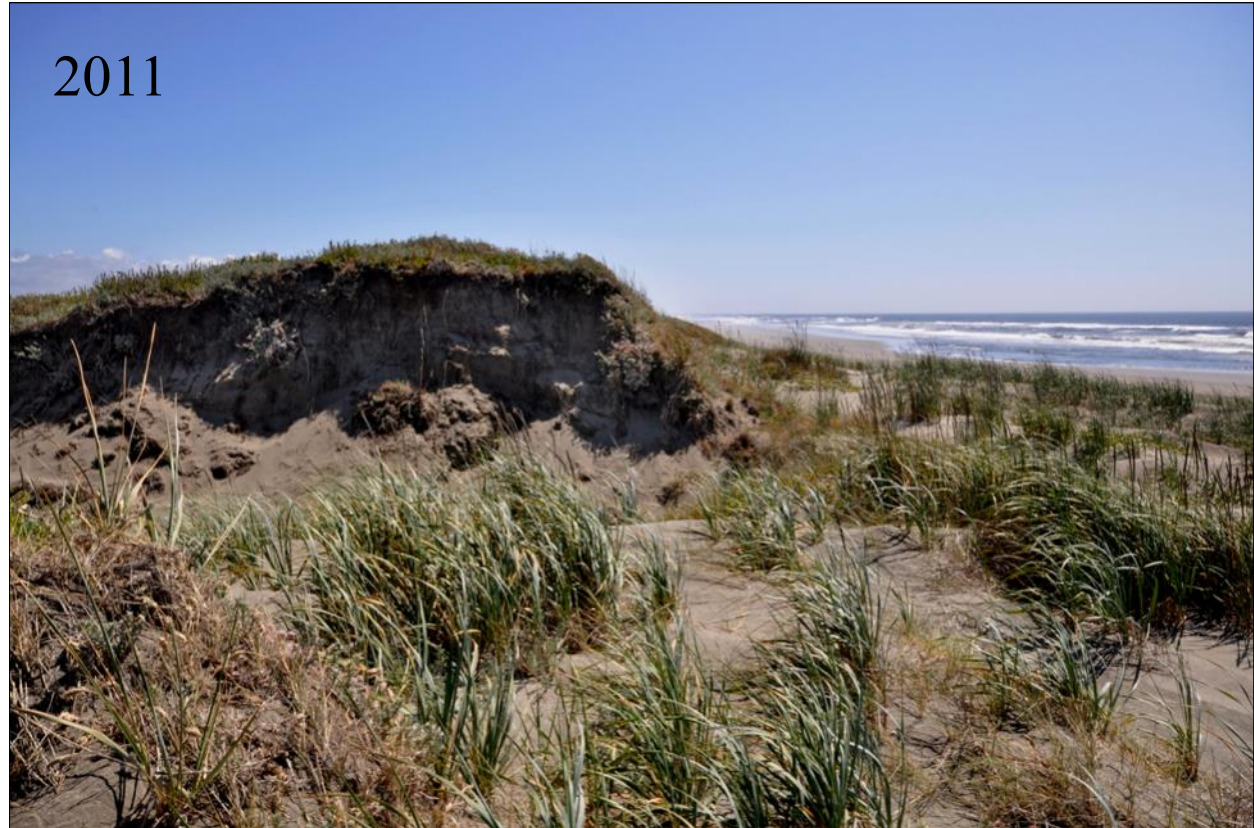
Photopoint 3a continued

The downwind wall of the blowout has become more vertical as the blowout further deflated. However, an incipient foredune has formed, closing the mouth of the blowout.

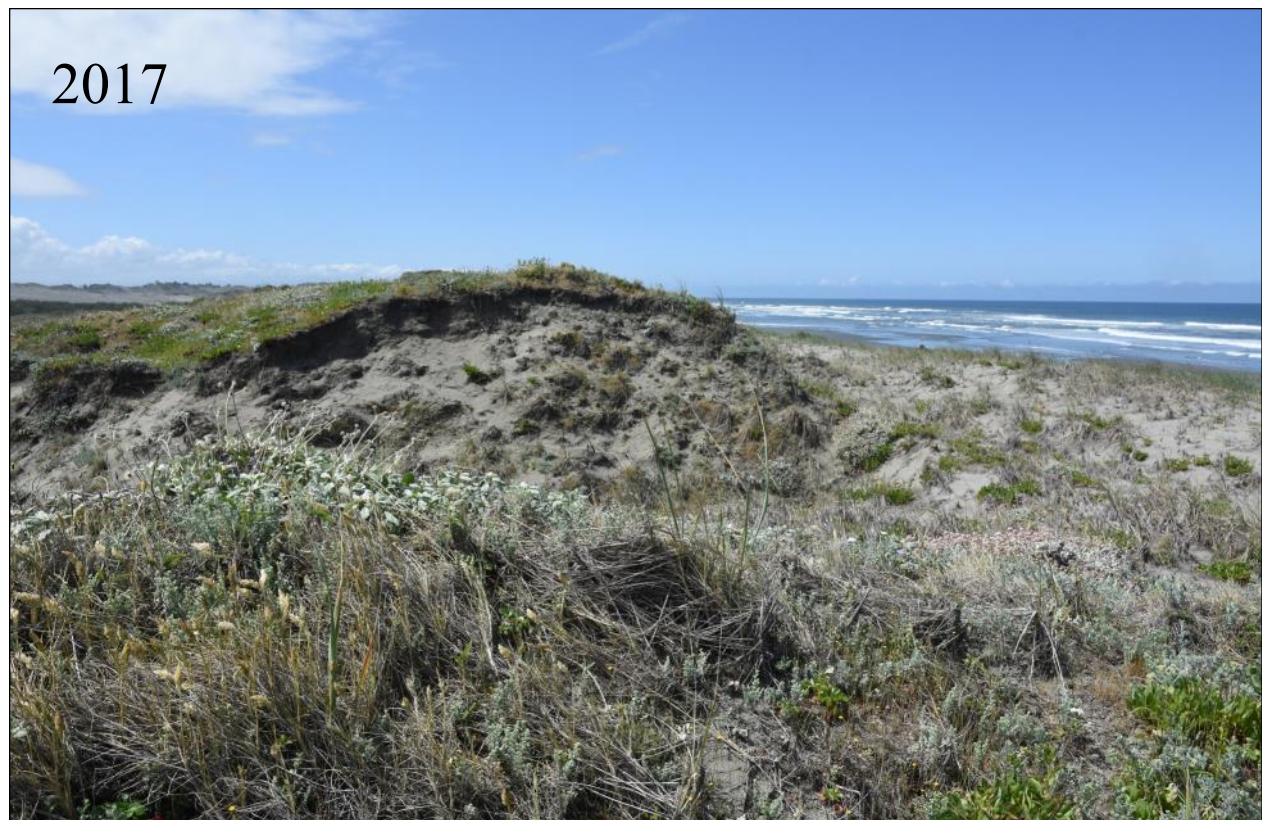
With increasing stabilization of the incipient foredune, the blowout is less active, and the downwind wall, although still steep, is vegetating.

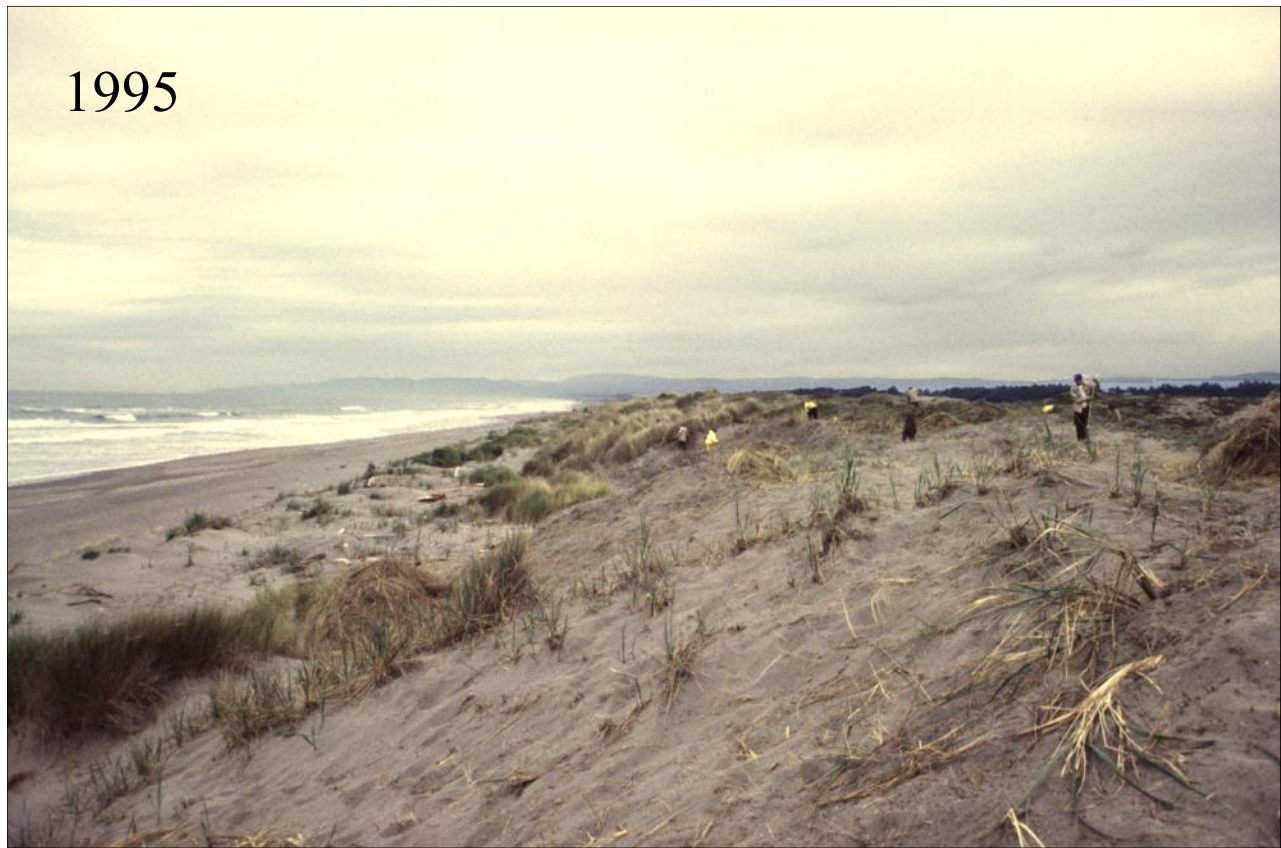
Photopoint 3b

The immediate foreground of the established foredune was cleared in 1994 and American dunegrass is colonizing. The background area is being treated for the first time. An incipient foredune is present and untreated, but not densely vegetated.

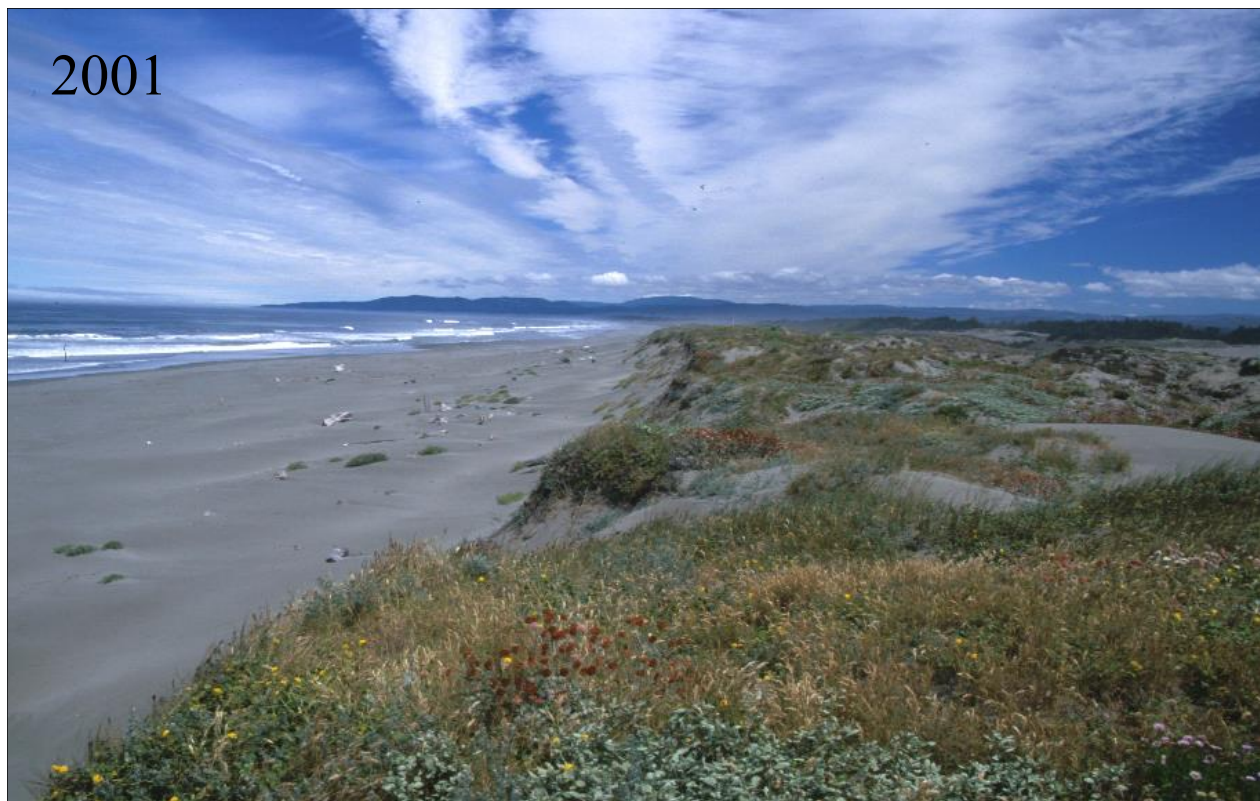
During the 1998-99 La Niña, the incipient foredune was completely removed, and the established foredune was scarped. On the crest of the foredune, native vegetation has colonized, including beach bluegrass, beach buckwheat, beach bursage, and yellow sand-verbena.

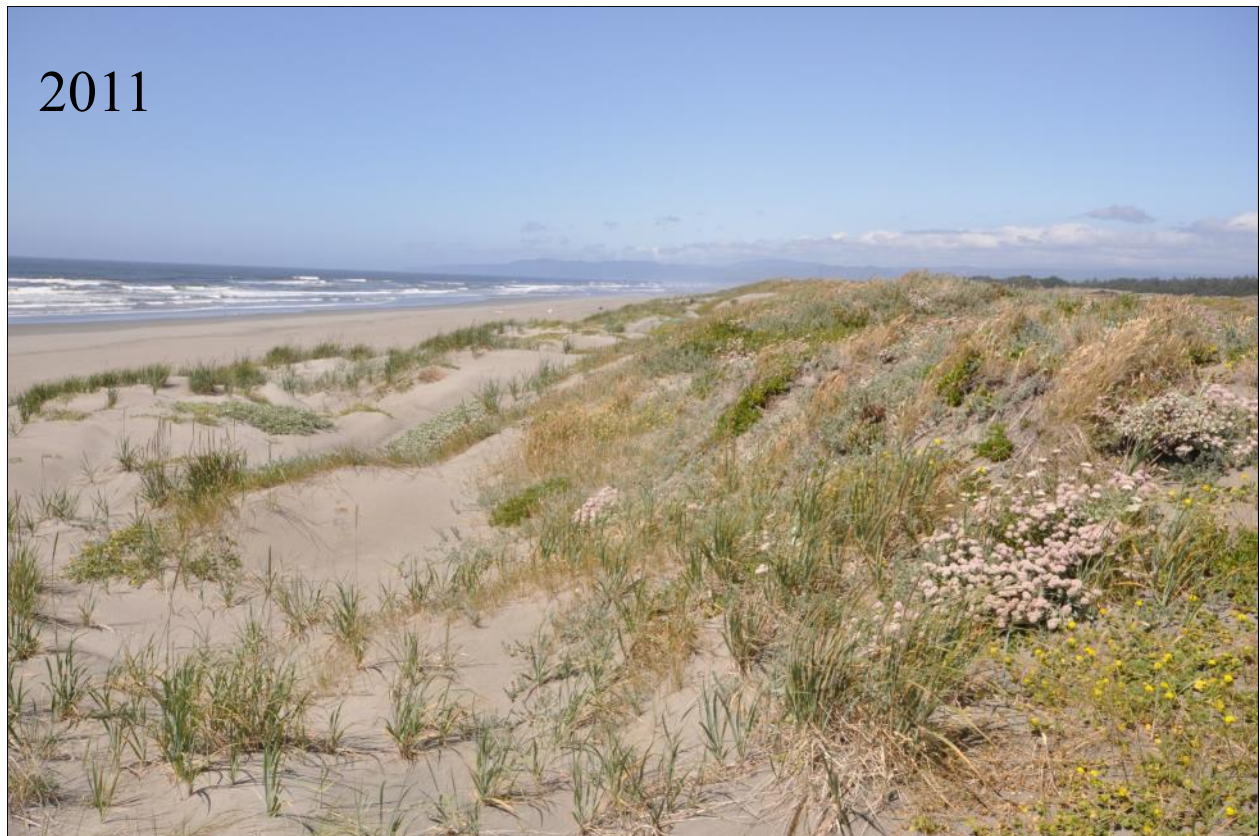
Photopoint 3b continued

A broad incipient foredune has reformed and is being colonized primarily by American dunegrass.

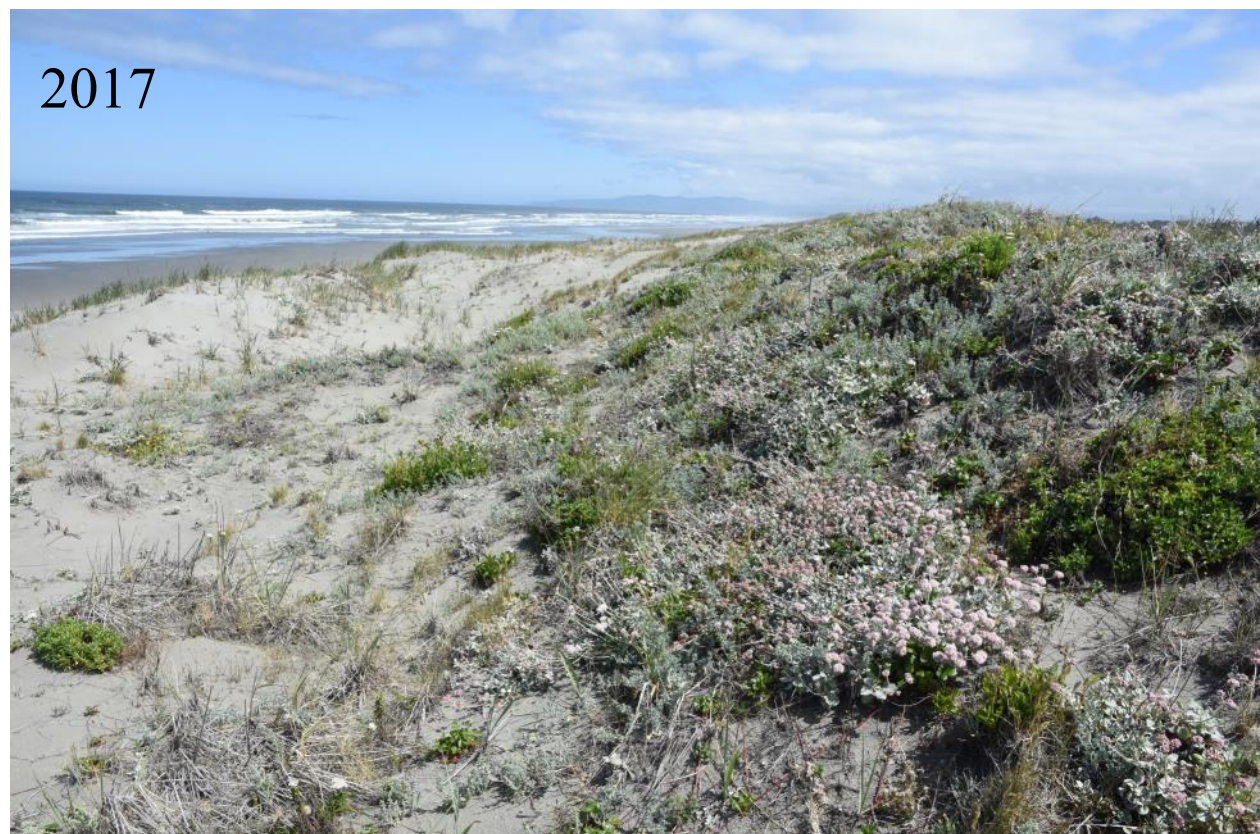
The established and incipient foredunes are similar to the preceding photo, however, species diversity on the incipient foredune has increased, especially in the foredune swale.

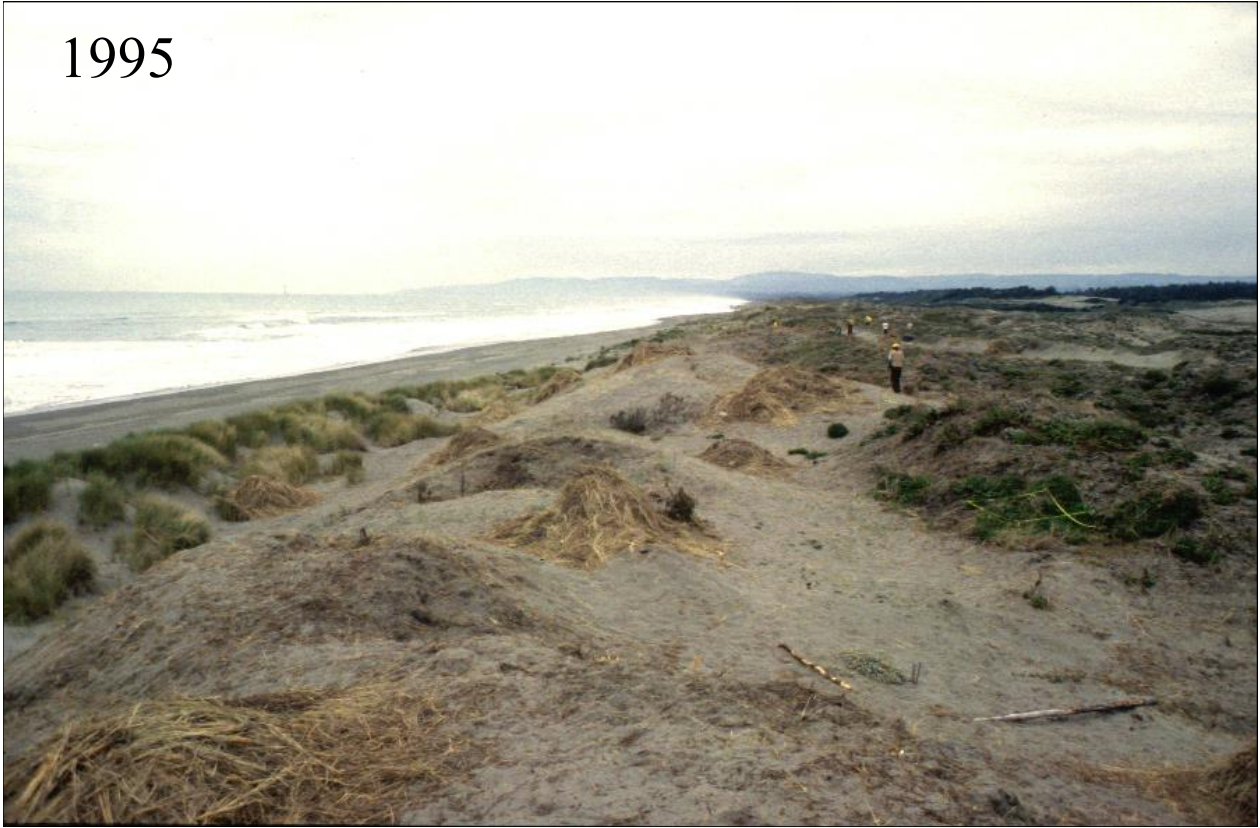
1995

This area includes some previously treated areas (background, right), while the foreground has just been treated for the first time. The incipient foredune was not cleared until the following year.

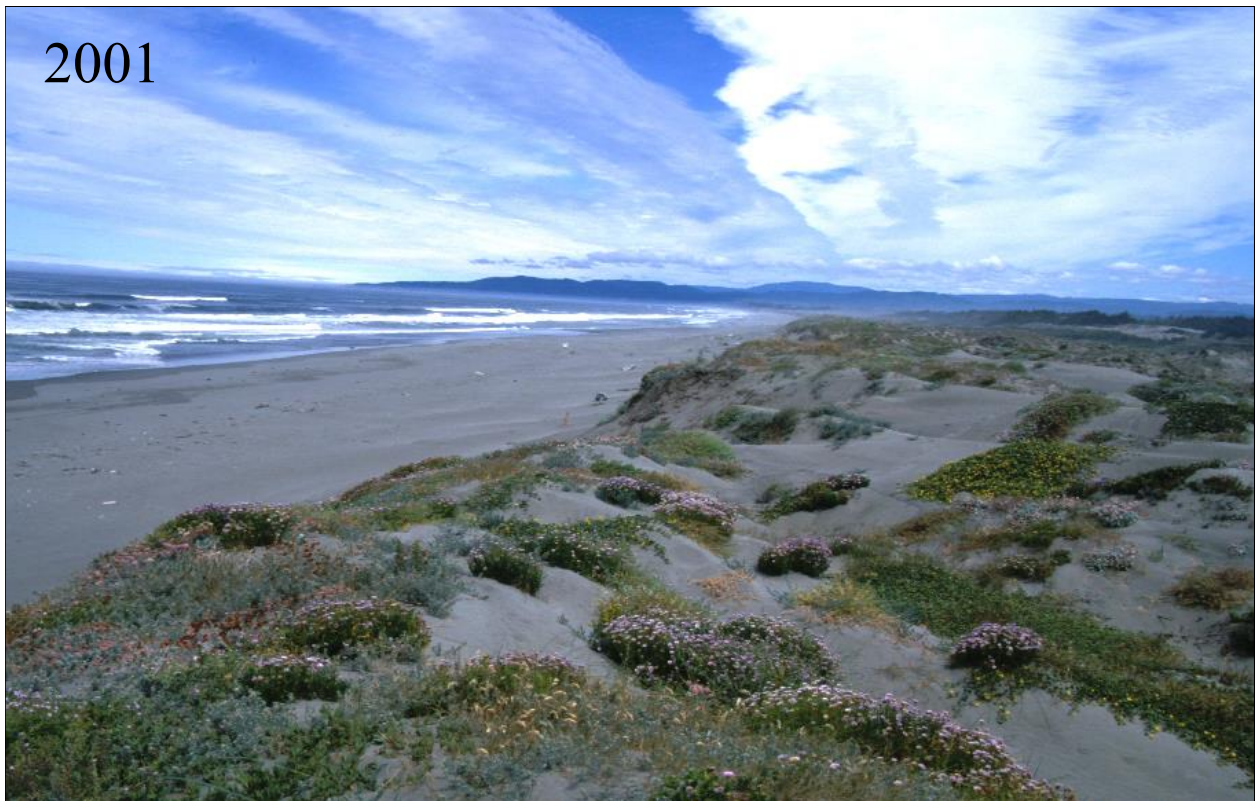
2001

Early successional native species have colonized, but cover is still low. The incipient foredune was removed during the 1998-99 La Niña, and the established foredune scarped.

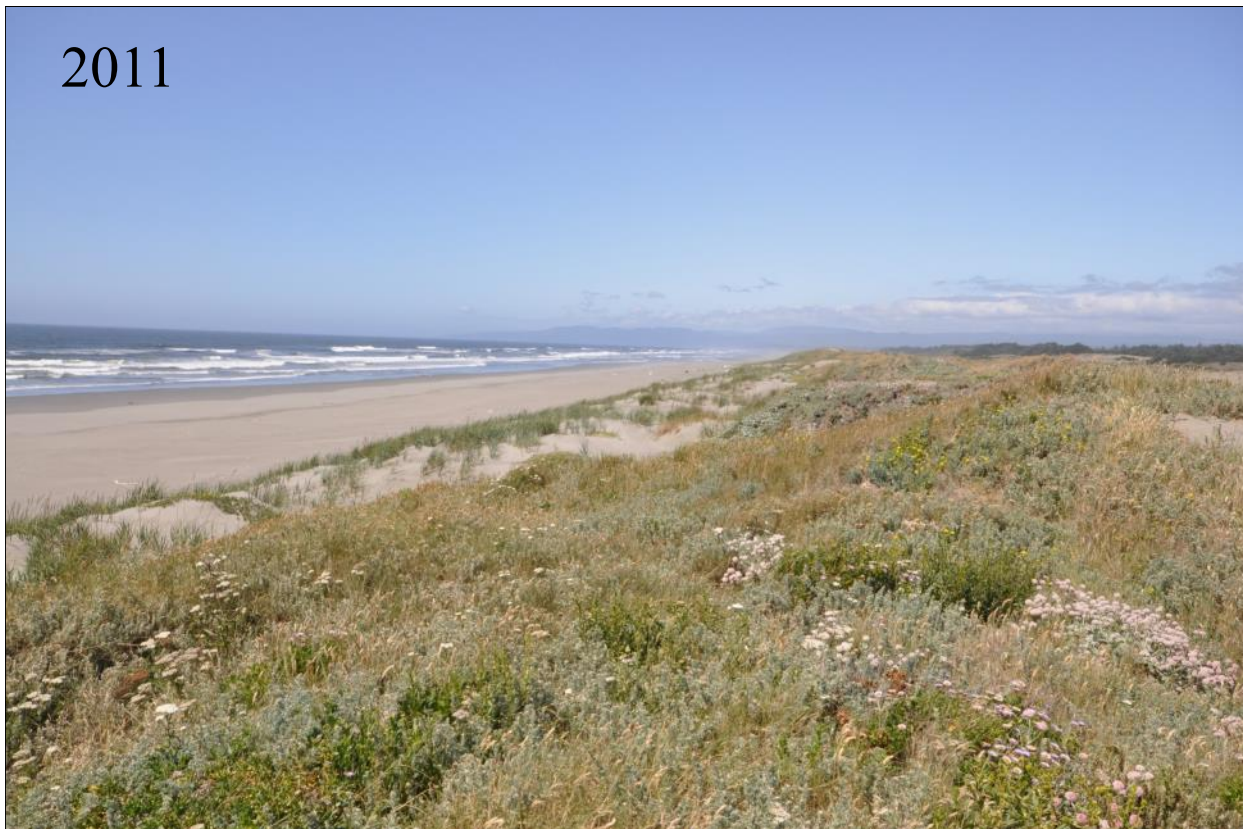
2011

The established foredune is now densely vegetated, and a new incipient foredune has been built by American dunegrass.

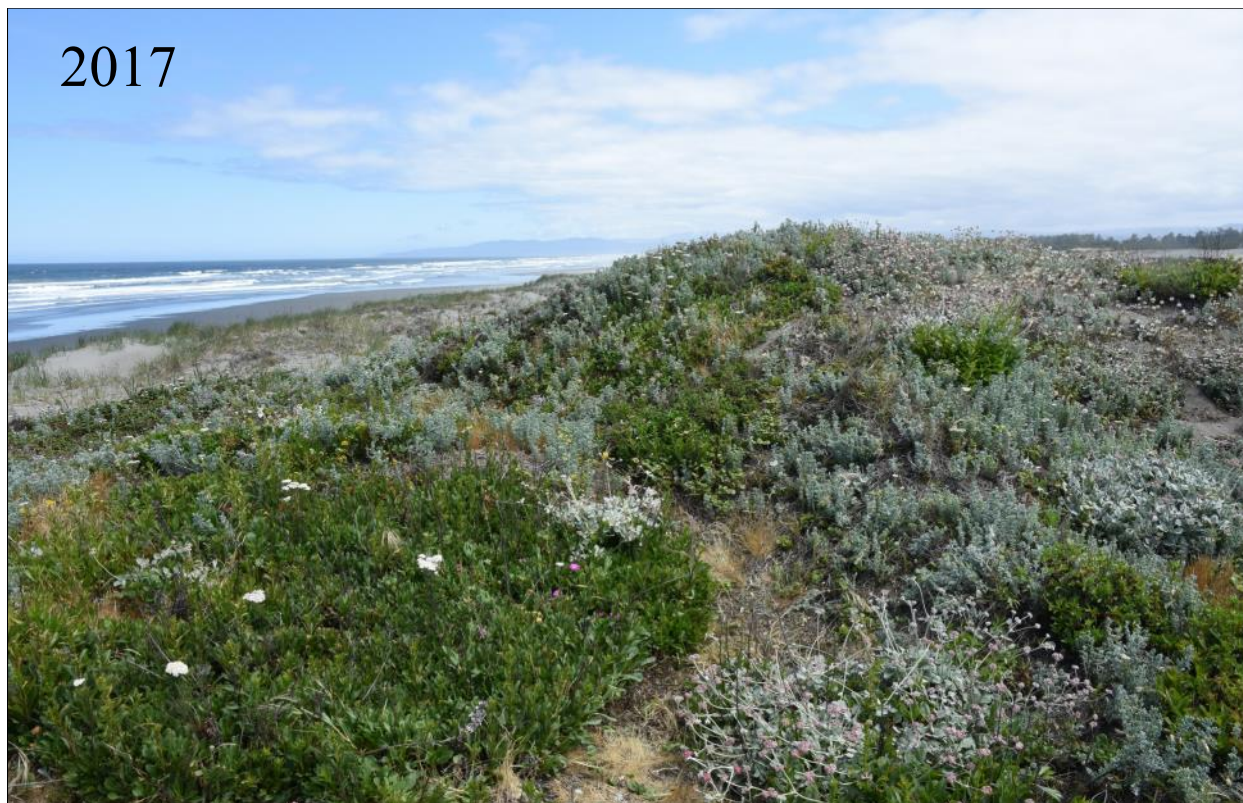
2017

Species composition on the established foredune has shifted and is now dominated by later successional dune goldenrod. The incipient foredune is still present.
